# Manhole Inspection Summary

Manhole # S25I\_\_067MH

Insp Date: **3/14/08 11:10 AM**

**Location** Address: **1200 W.LOMBARD ST.**

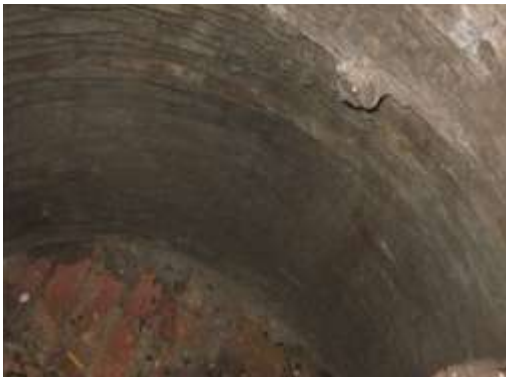
Defect 5

Infiltration: ☐ None ☐ Joint ☐ Cracks ☐ Mortar ☐ Roots ☒ **Wall**

EVIDENCE OF INFILTRATION AT THE BARREL

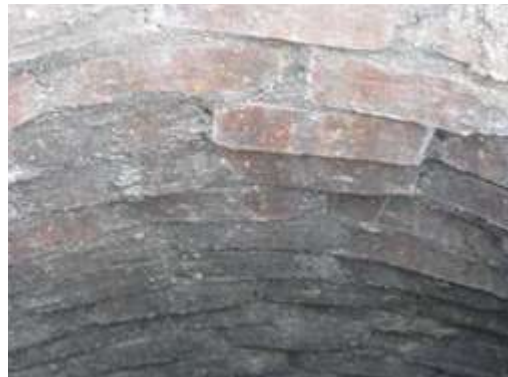
Defect 4

Infiltration: ☐ None ☐ Joint ☐ Cracks ☐ Mortar ☐ Roots ☒ **Wall**

EVIDENCE OF INFILTRATION AT THE CORBEL

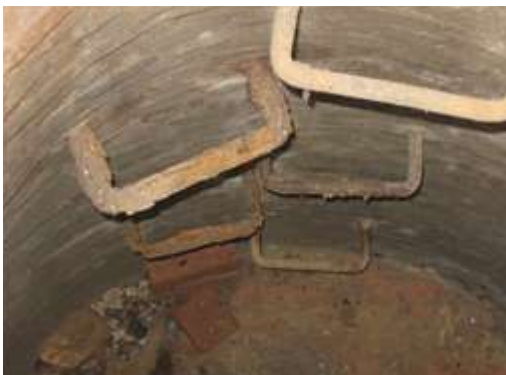
Defect 3

Count: **5** Missing: **0** ☒ **Corroded**

CORRODED STEPS AND DEBRIS AT BOTTOM OF MANHOLE

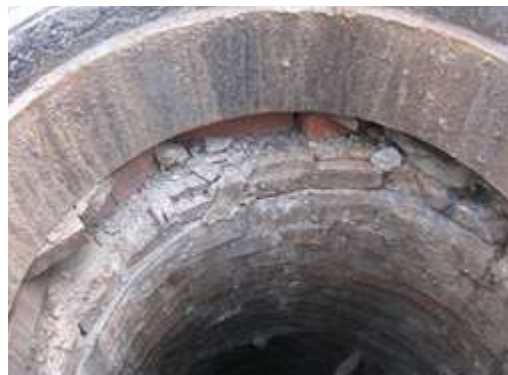
Defect 1

Condition: ☐ Sound ☒ **Cracked** ☐ Root Intrusion ☒ **Loose Brick** ☒ **Deteriorated**

Infiltration: ☐ None ☐ Joint ☒ **Cracks** ☒ **Mortar** ☐ Roots ☐ Wall

EVIDENCE OF INFILTRATION AT THE DETERIORATED CHIMNEY FROM MISSING MORTAR AND BRICK

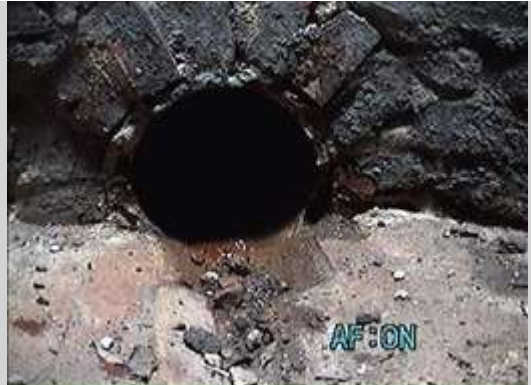
12 O'Clock Outflow

8 in. Circular Gravity Sewer  
Pipe Out @ 12 O'Clock

Infiltration: **None** Pipe Seal Cond: **Sound**
